TOYOTA 官方 TIS3使用说明[图片]

## Known Bugs List

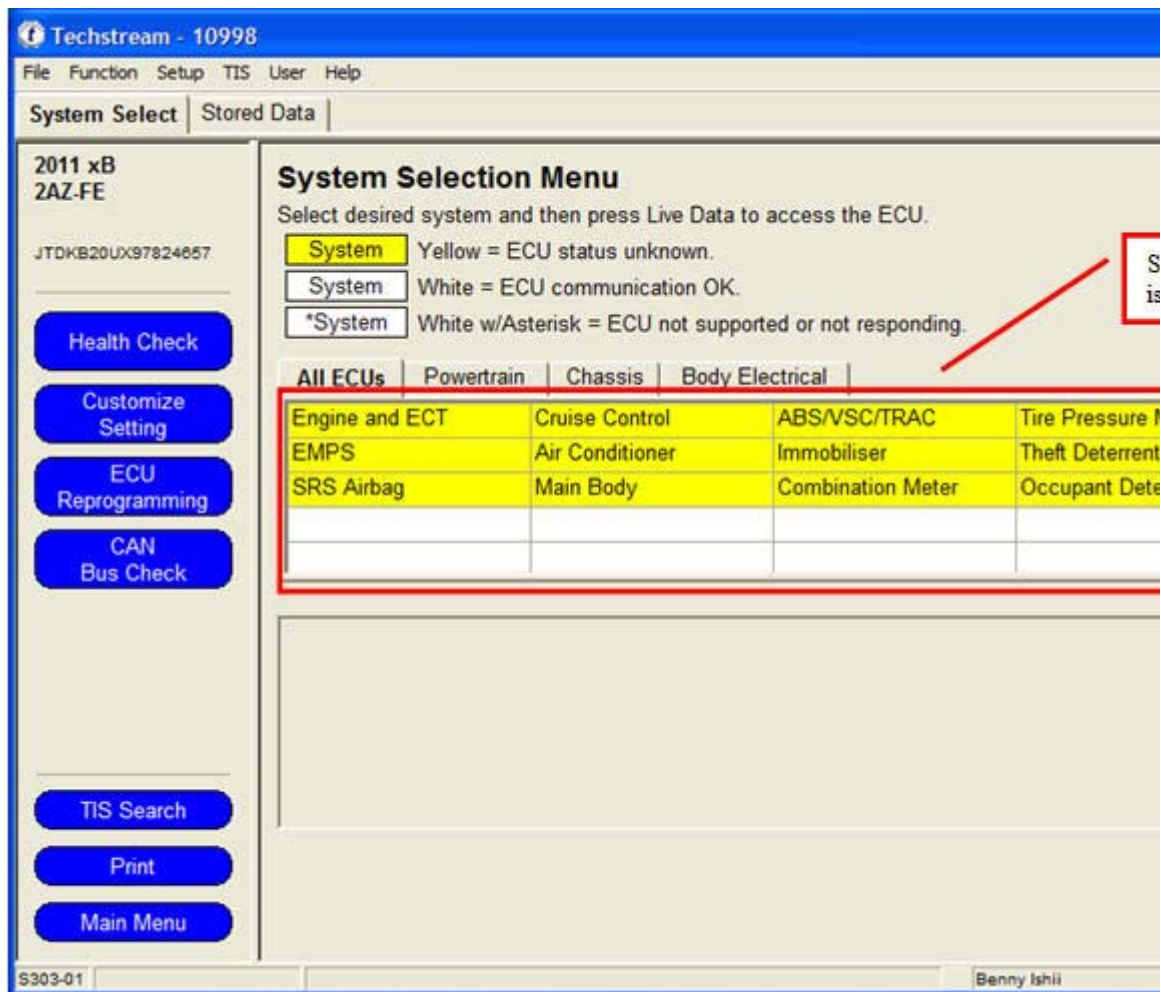
### 4. Sliding Roof System is Missing

**Description:**The Sliding Roof system is missing from the System Select Menu.

**Work Around:**The Sliding Roof system can be accessed by manually selecting the vehicle as a 2011MY Highlander with 2GR-FE engine.

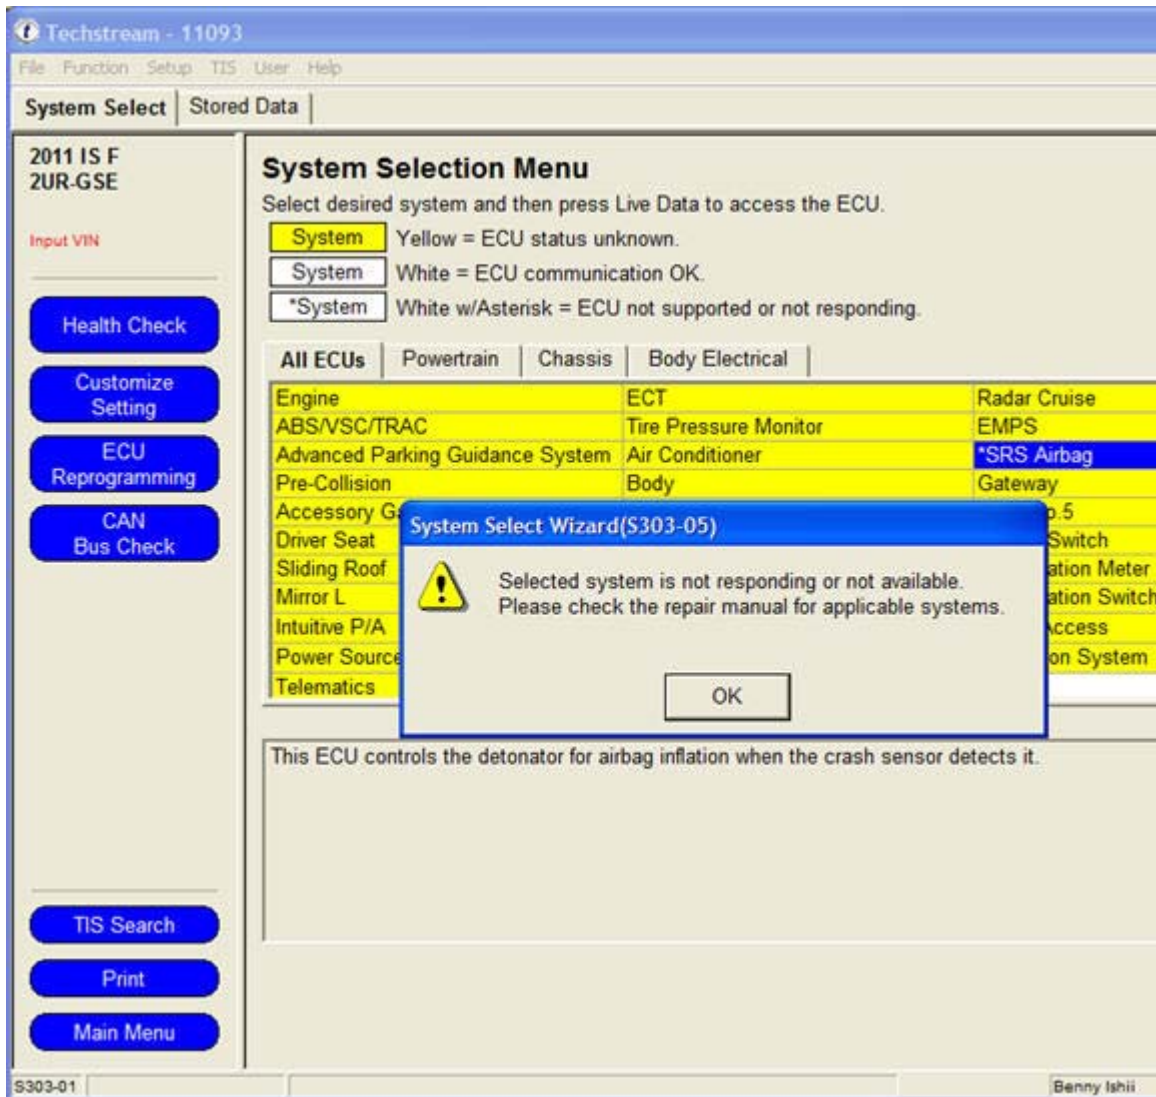
## 5. Unable to Connect to SRS Airbag System

**Description:**The SRS Airbag System cannot be accessed and the System Select Screen will indicate that the system is not available.

**Work Around:**The SRS Airbag system can be accessed by manually selecting the vehicle as a 2011MY IS350.

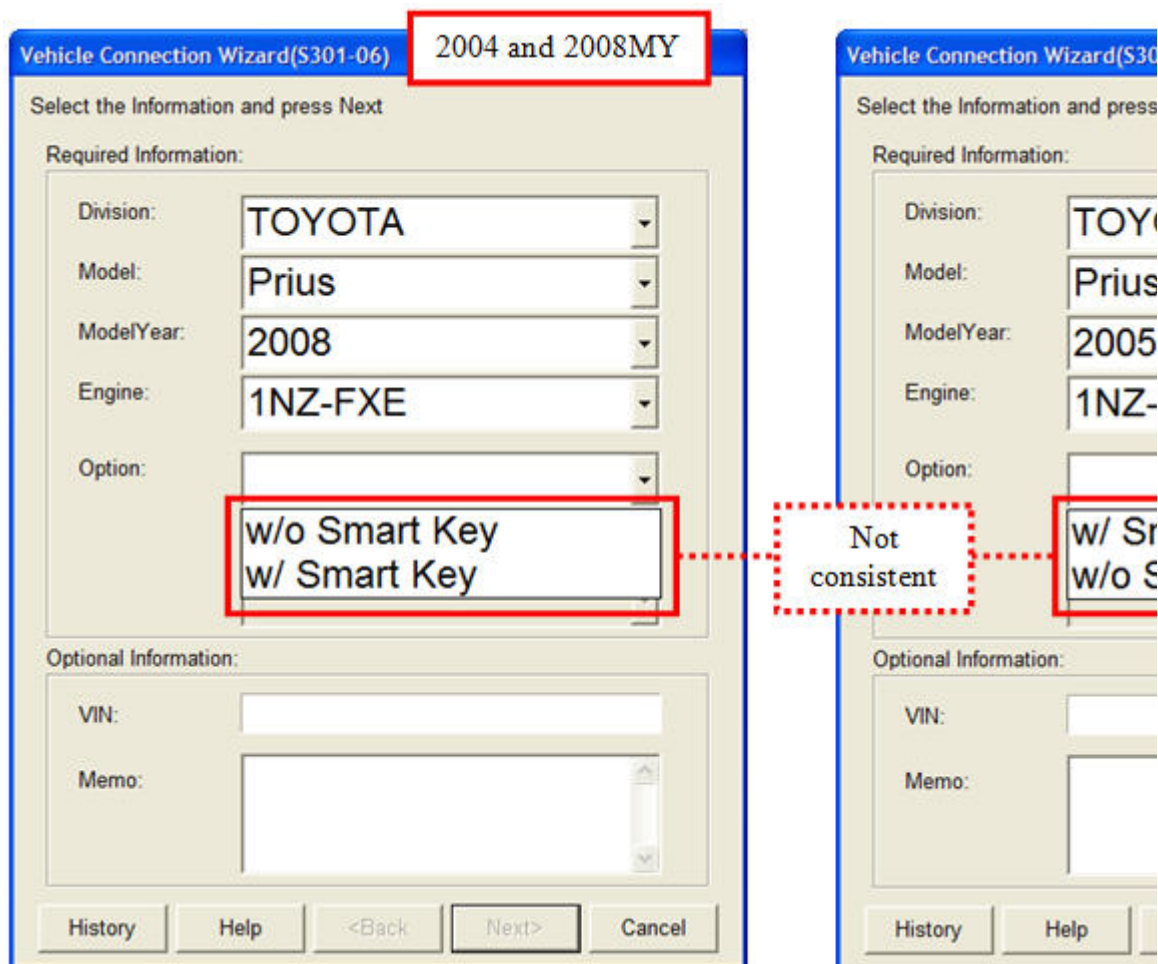
## 8. Option Selection is Inconsistent

**Description:**When connecting to this vehicle, the Smart Key option selection display order is inconsistent and will vary depending on model year.

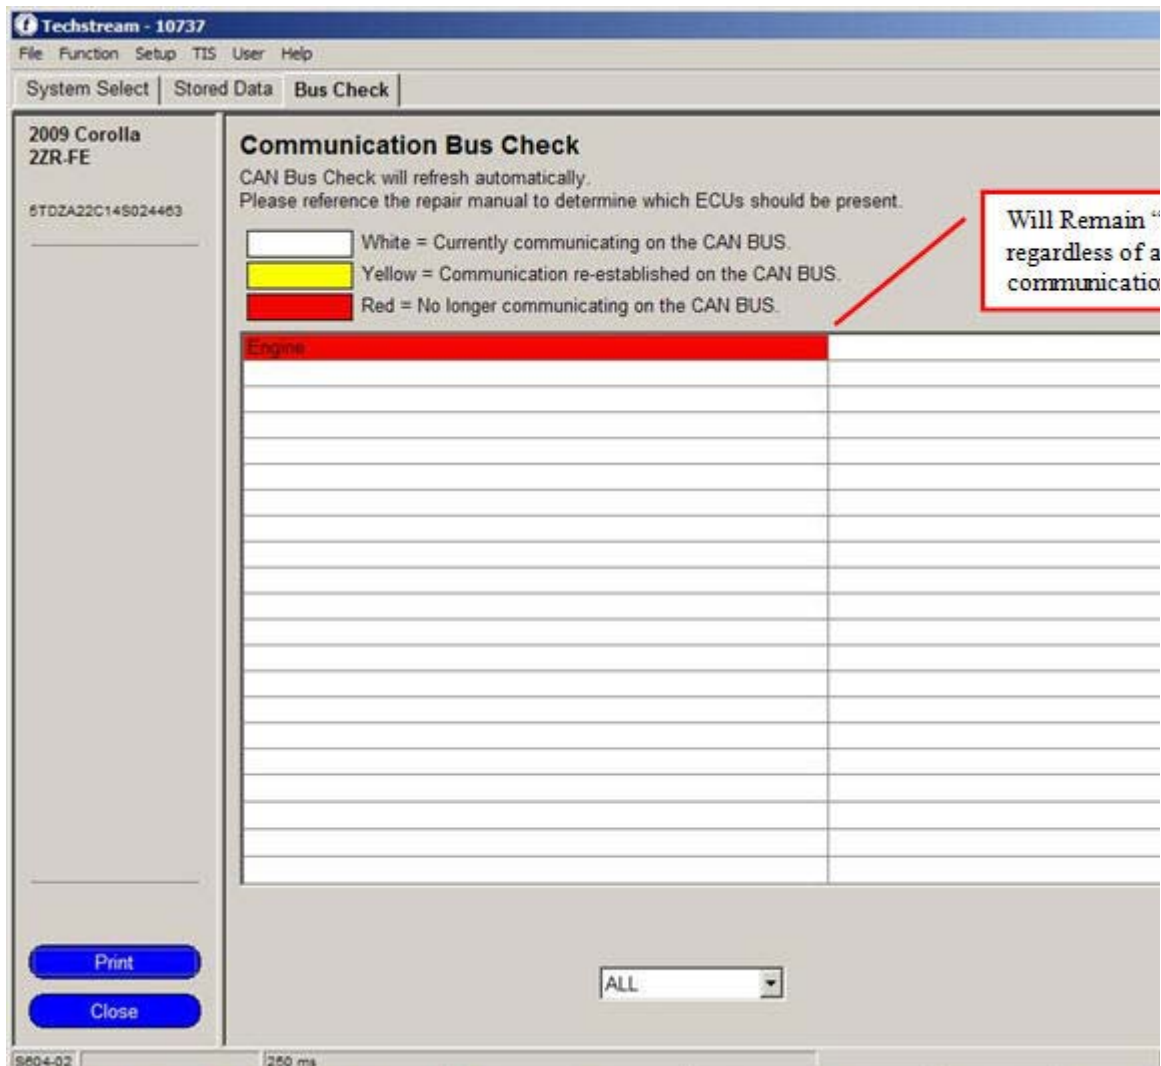
## 9. CAN Bus Check Malfunction

**Description:**When viewing the CAN Bus Check screen using the Mongoose VIM, the available ECUs will change status to "no longer communicating" after a few seconds.

The status will remain "red" regardless of whether it is actually connected or not.

**Status:**Issue is under investigation. In the meantime, please use Full Techstream to diagnose CAN Bus related issues.

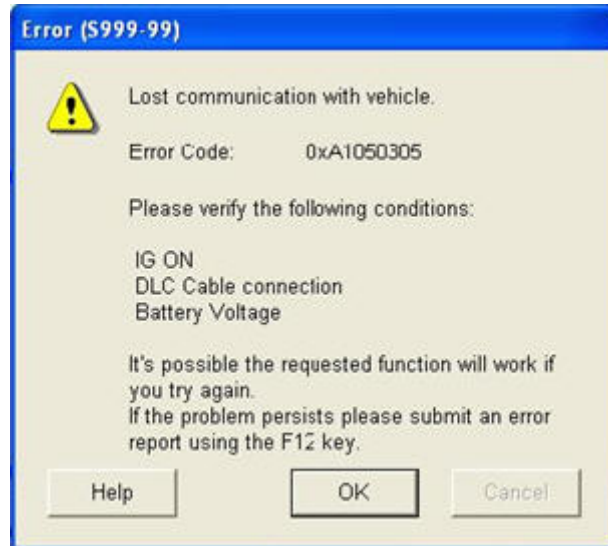
## 10. Intermittent Data List Error

**Description:**When viewing the Engine and ECT Data List using the Mongoose VIM intermittent errors may occur.

**Status:**Issue is under investigation. If this error is encountered, please submit ar

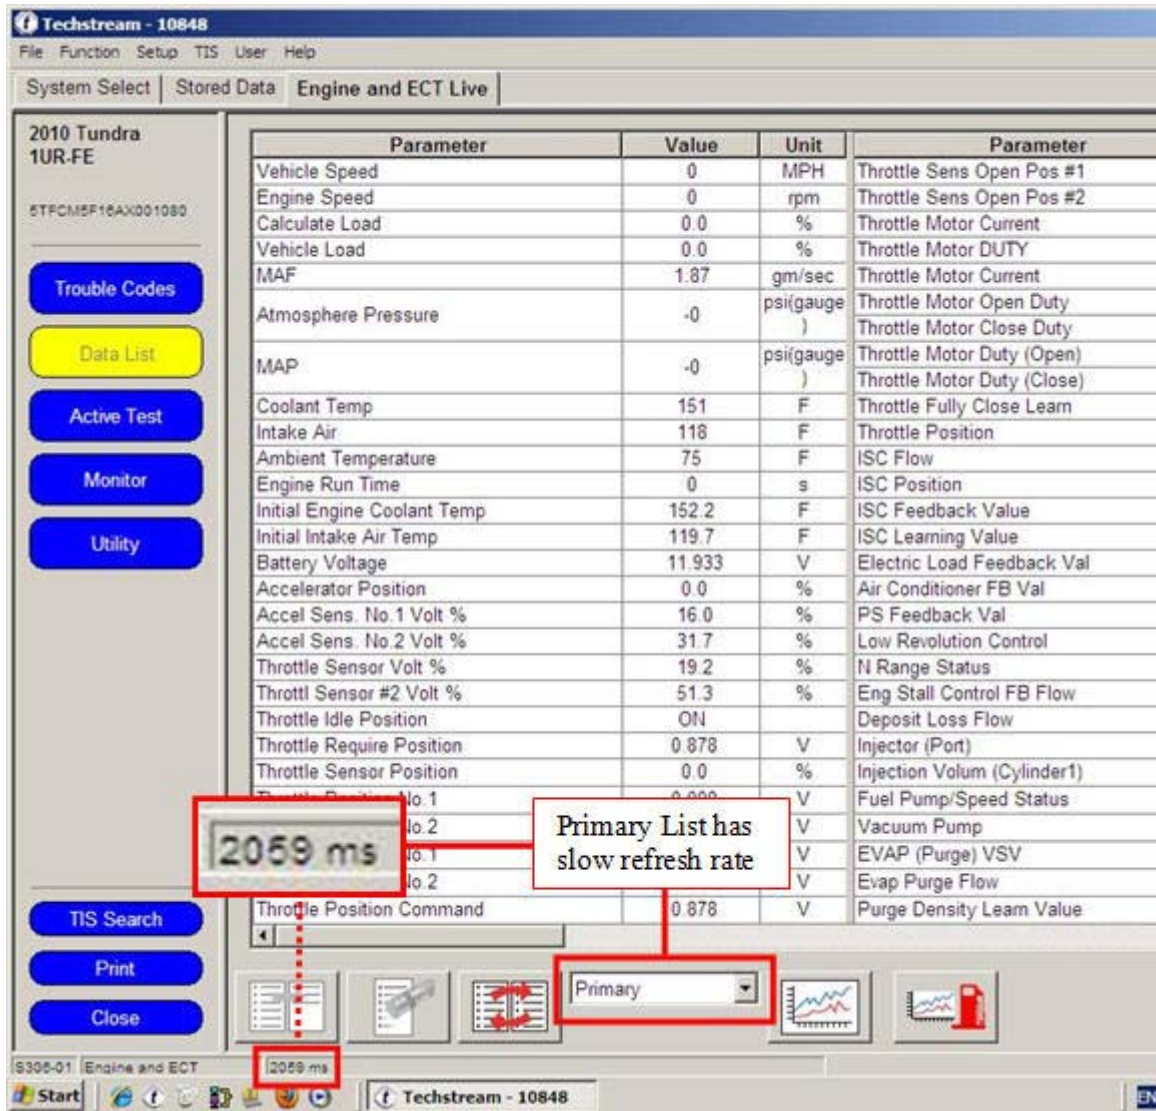
## 11. Slow Refresh Rate When Viewing "Primary" Data List

**Description:**When viewing the Engine and ECT Data List in "Primary Data," the refresh rate is over 2000 msec.

**Status:**Issue is under investigation. In the meantime, to work around this issue please remove about 20-25 unnecessary parameters from the "Primary" list and the refresh rate should drop down to 200 msec.

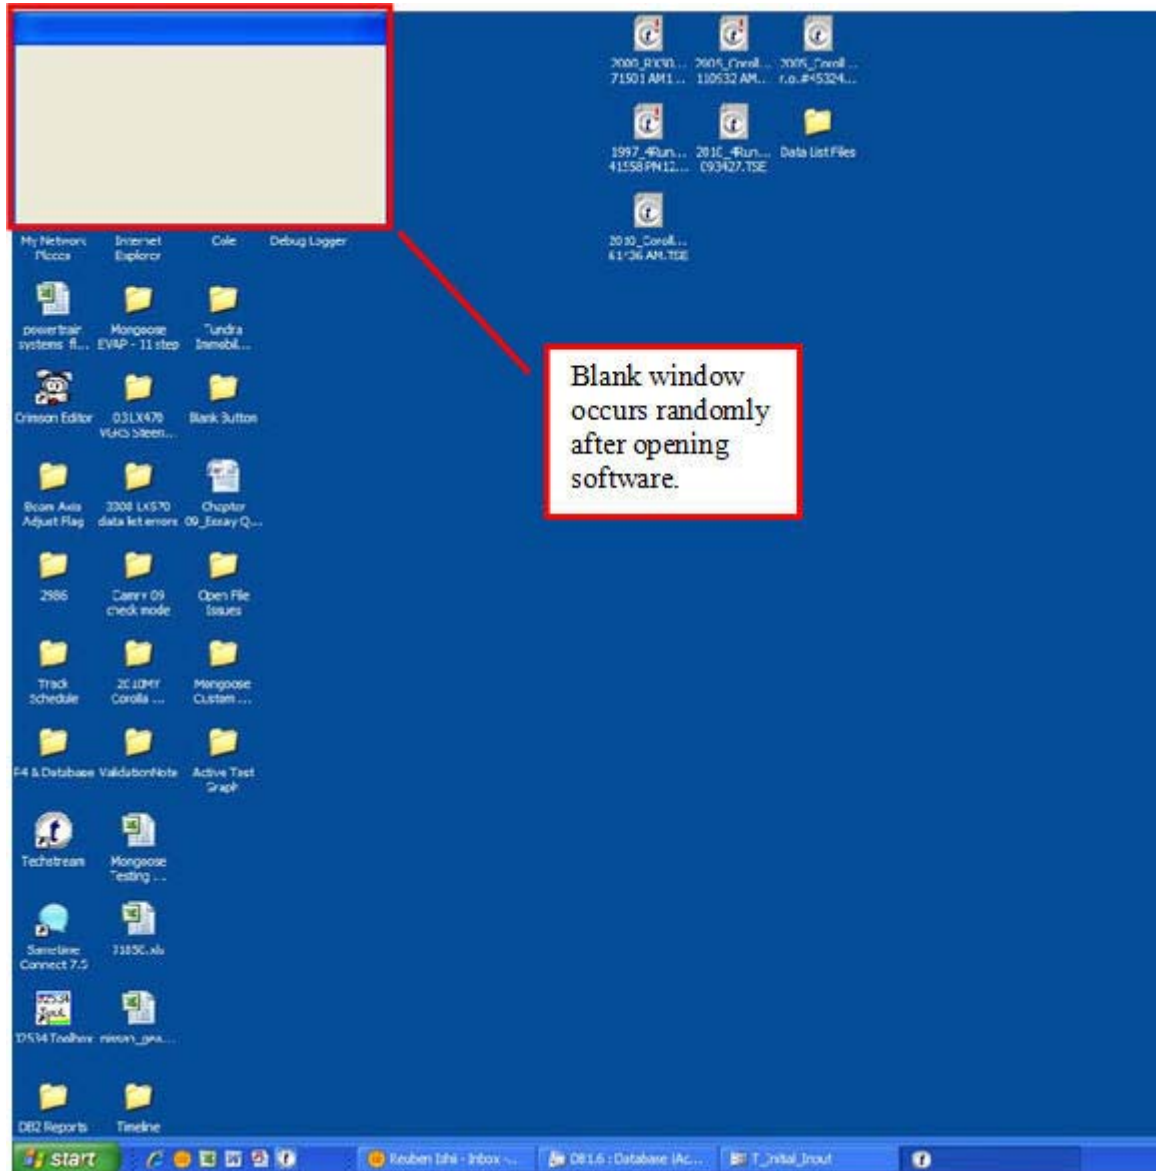
## 12. Random Error When Opening Software

**Description:**When opening Techstream Software, an error will randomly occur in which a blank window will display in the upper left hand corner.

**Status:**Issue is under investigation. In the meantime, to work around this issue

please open the Windows Task Manager and end the "MainMenu.exe" process.

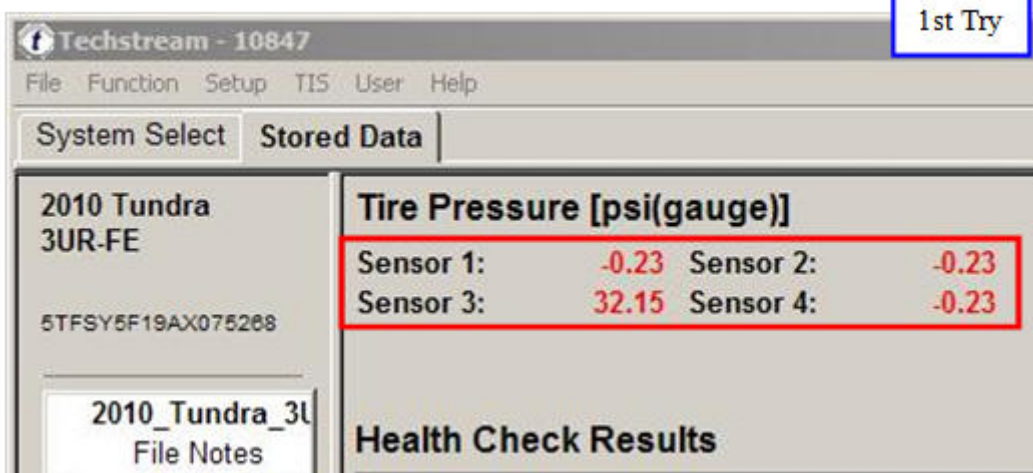
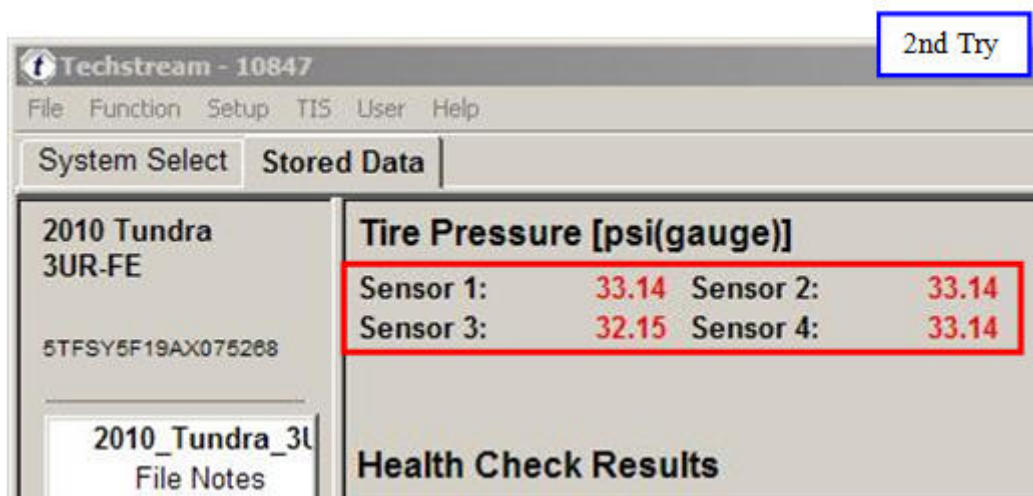
#### 14. Tire Pressure Values from Health Check Result Screen are Intermittently Inaccurate

**Description:**After performing a Health Check, the Tire Pressure Values are intermittently inaccurate and display negative values. This occurs when the Health Check is performed within 2-3 minutes of turning the IG key ON.

**Status:**Issue is under investigation. In the meantime, either wait a few minutes after turning the IG ON before doing a Health Check, or refresh the Health Check results if the values are incorrect.

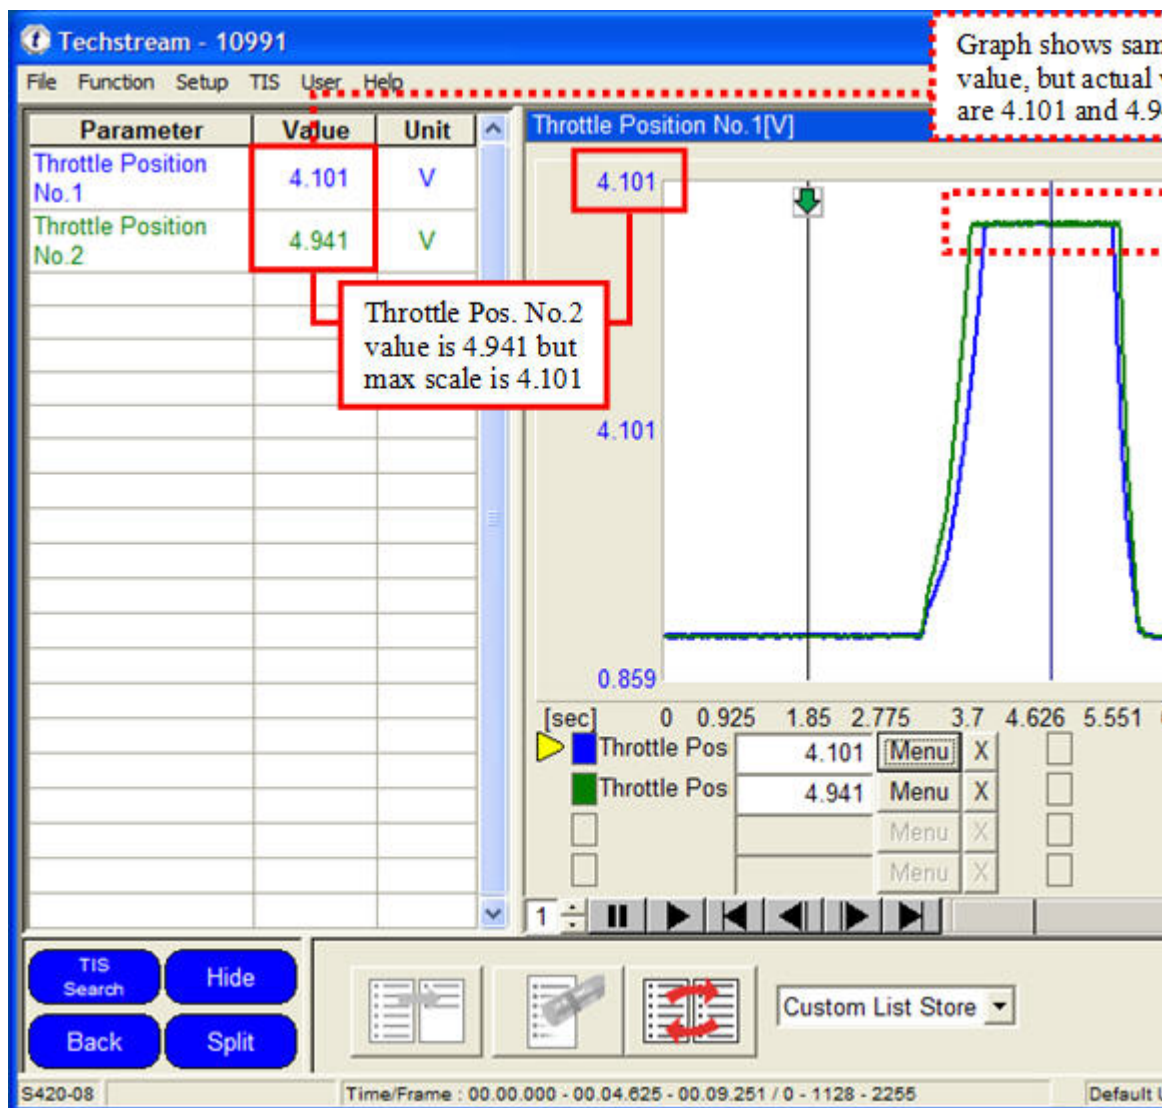
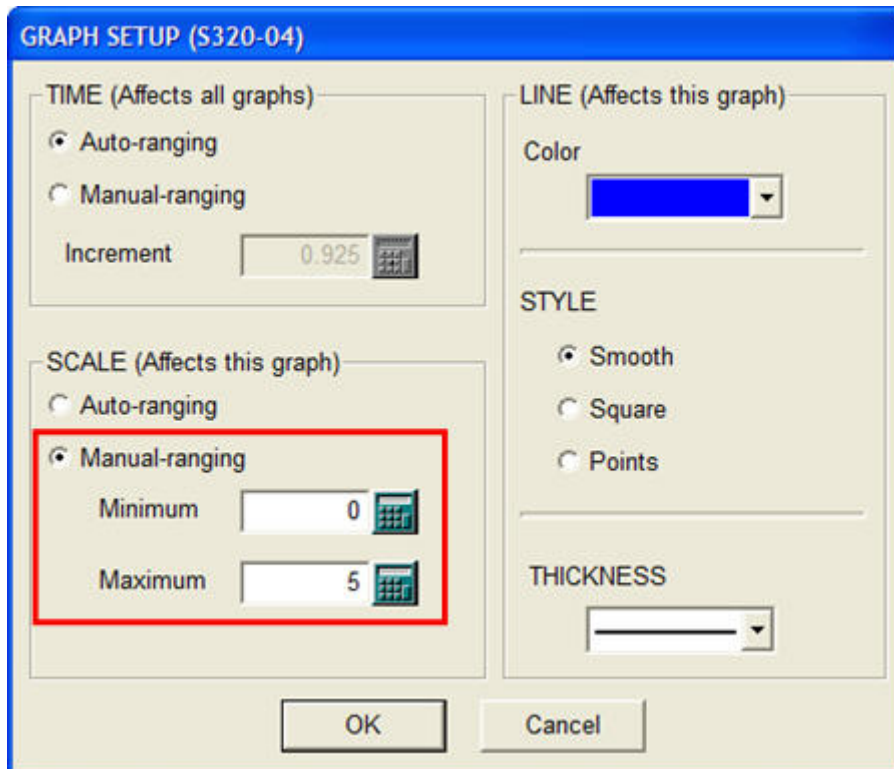
## 16. Overlap Graph Scaling is Incorrect

**Description:**When overlapping Throttle Position No.1 and Throttle Position No.2 graphs, the max scale value is not set properly. Although the max value of Throttle Position No.2 is higher than Throttle Position No.1, they show as the same max value on the graph due to this error.

**Status:**Issue is under investigation. In the meantime, please manually set the Min/Max scale value to 0 and 5 volts so the graphs will display properly.

**Work Around:**Manually change the scale to 0 and 5 in Graph Setup so the graph will

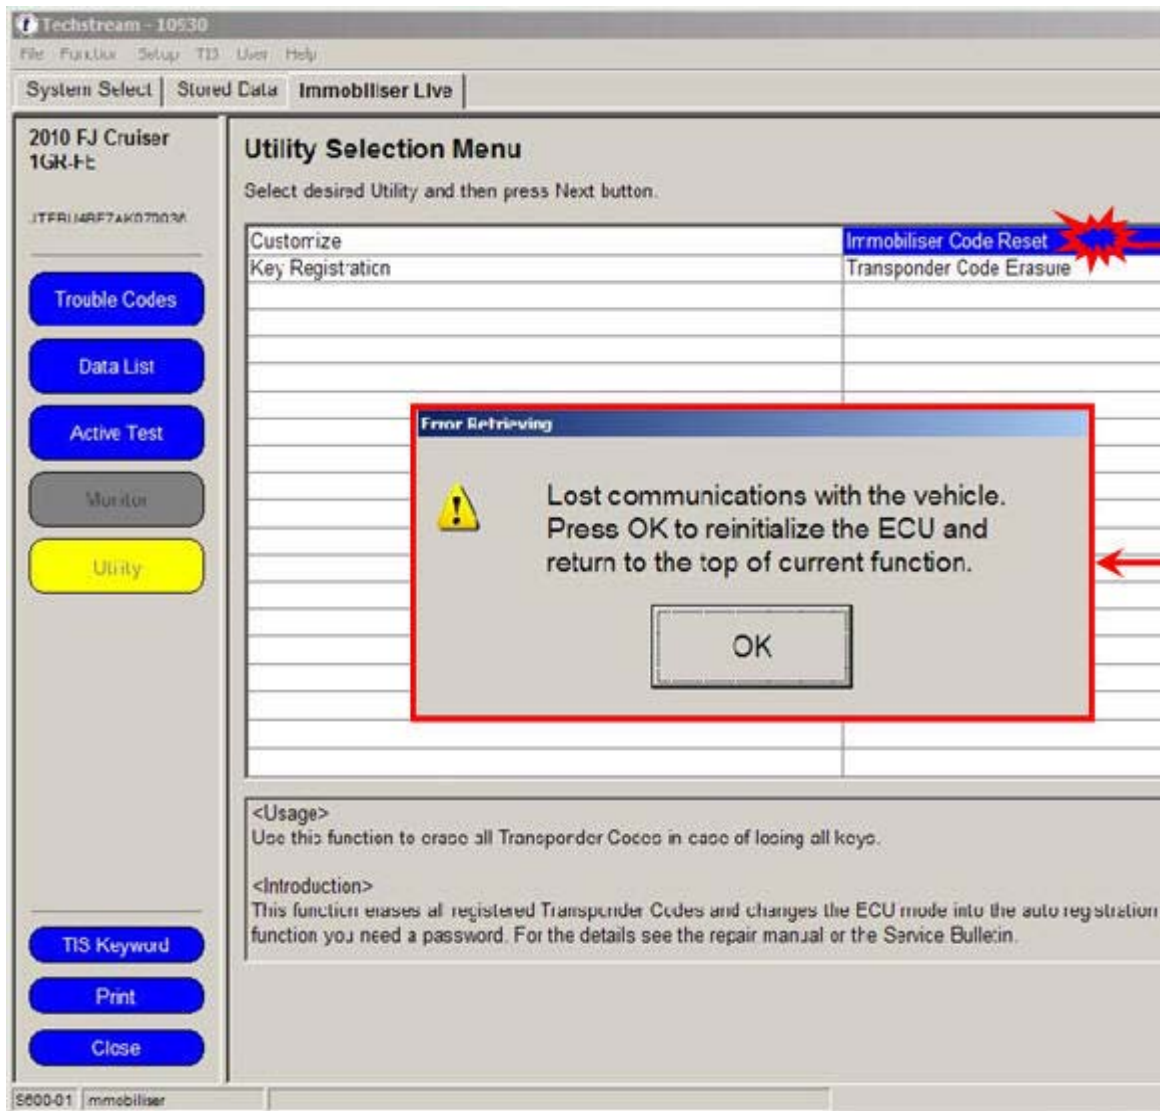
## 17. Unable to Access Immobilizer Reset Function

**Description:**When attempting to access the Immobilizer Reset Utility, an error window will indicate that communication with the vehicle has been lost.

**Status:**Issue is under investigation. In the meantime, if this error is encountered, please contact TAS for assistance.

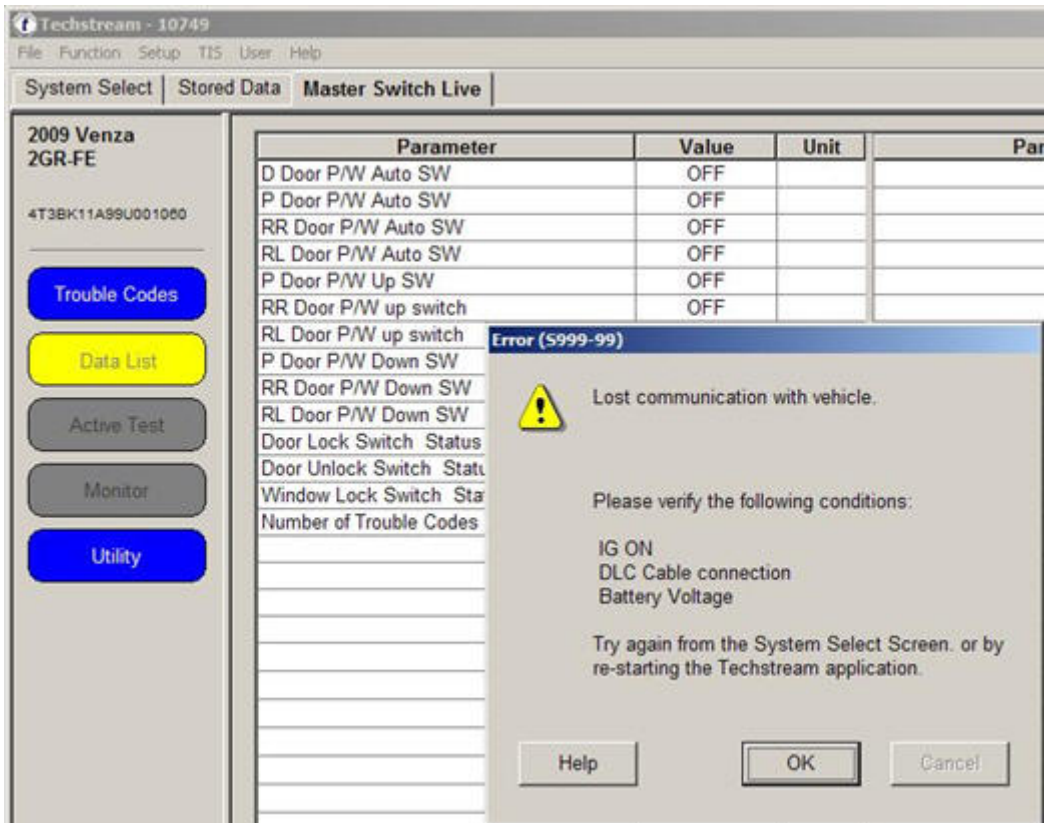
## 22. Locking/Unlocking Doors Causes Communication Error

**Description:**When using the Mongoose VIM, an error will result if the power door lock switch (lock or unlock) is operated while communicating with the vehicle. After this error occurs, communication cannot be established with any of the ECU's on the vehicle.

**Status:**Issue is under investigation. In order to re-establish communication to the vehicle, the software must be rebooted and the Mongoose USB connection must be removed and reconnected.

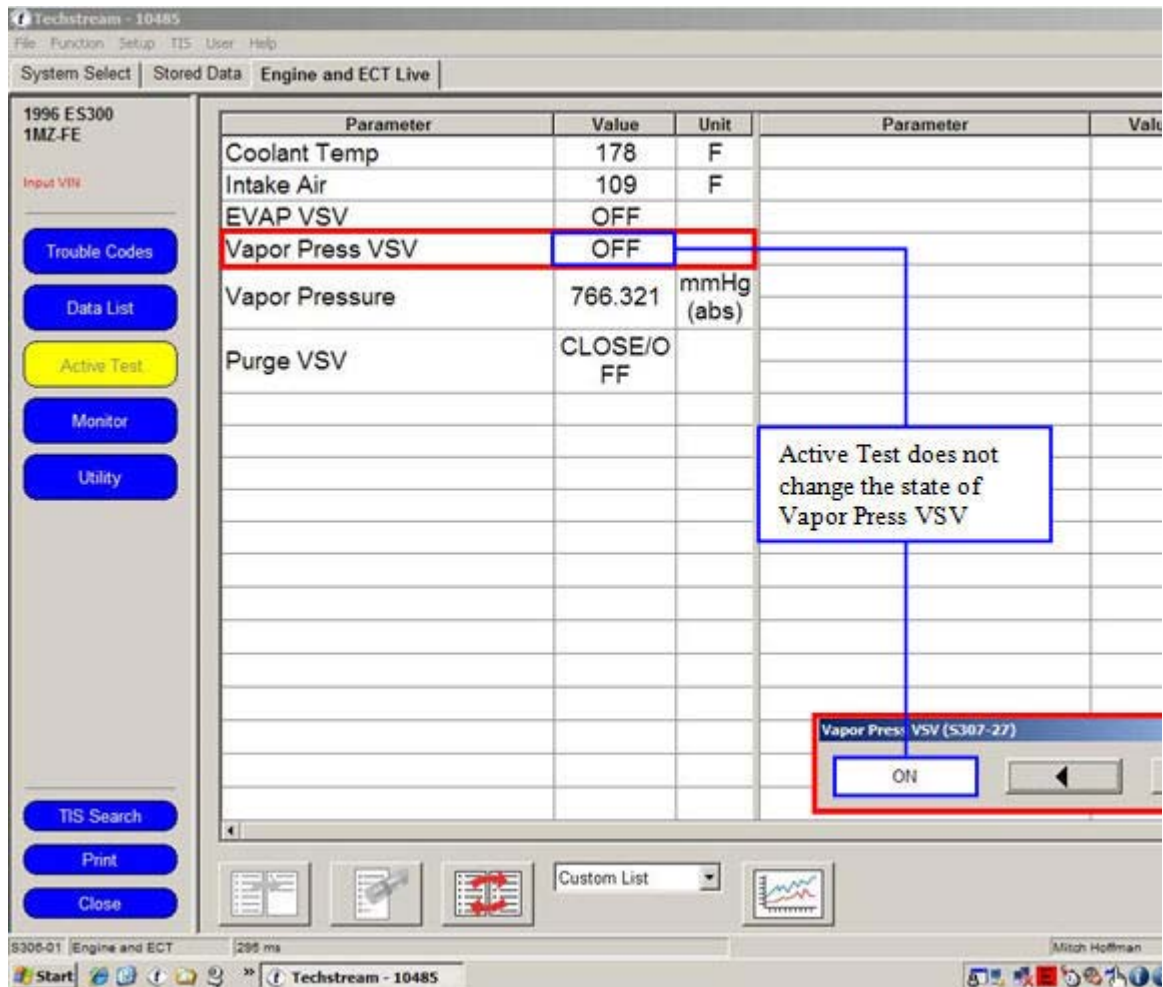
### 23. Vapor Press VSV Active Test Malfunction

**Description:**When changing the status of the Vapor Press VSV Active Test, the corresponding Vapor Press VSV data list parameter does not indicate any change.

**Status:**Issue is under investigation. In the meantime, we have received reports indicating that by cycling the active test status between ON and OFF multiple times will allow the active test to function properly.

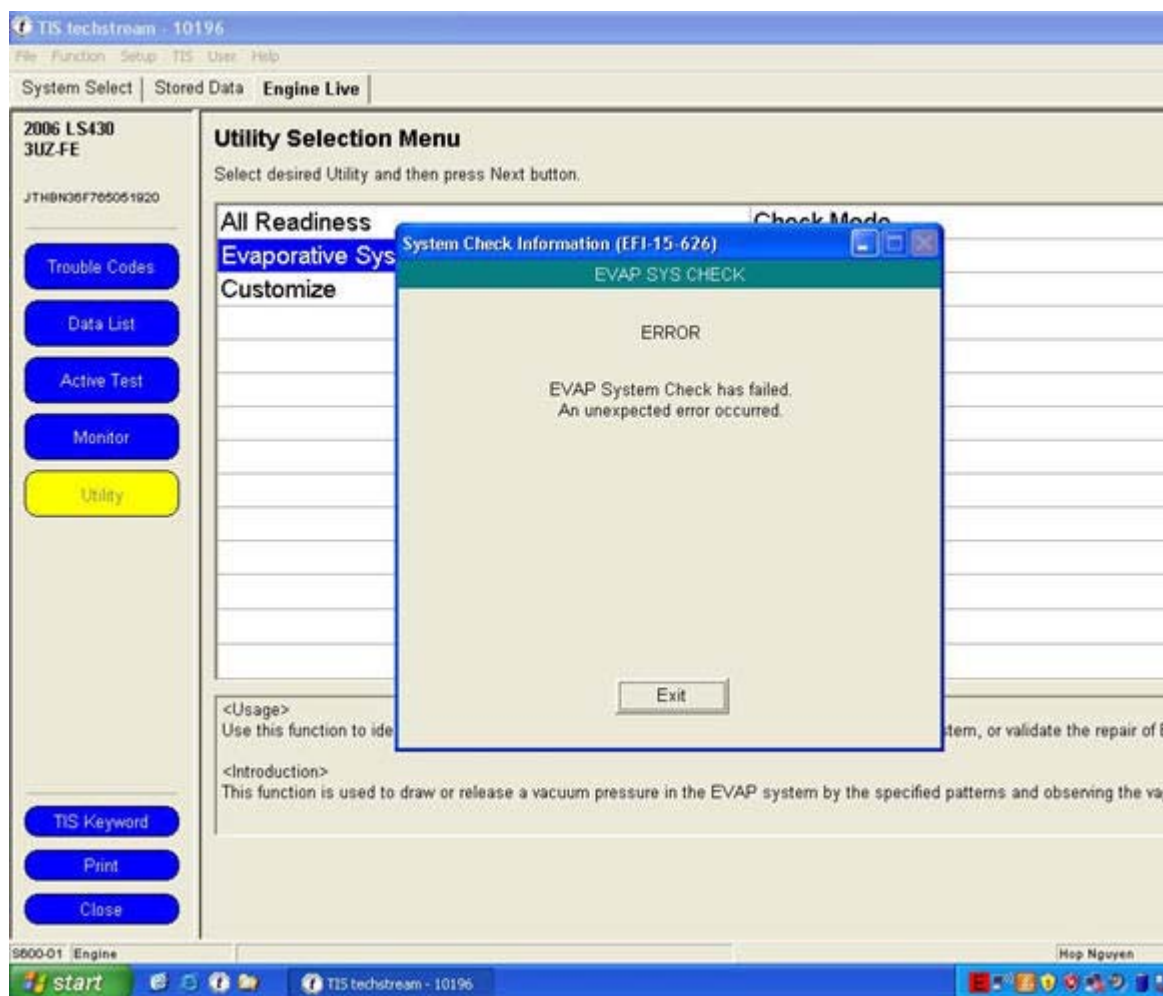
## 2. EVAP System Check Failure

**Description:**Attempting to perform EVAP System Check will result in error screen and the function will be inoperable. Please refer to the repair manual for instructions on manually inspecting the Evap System.

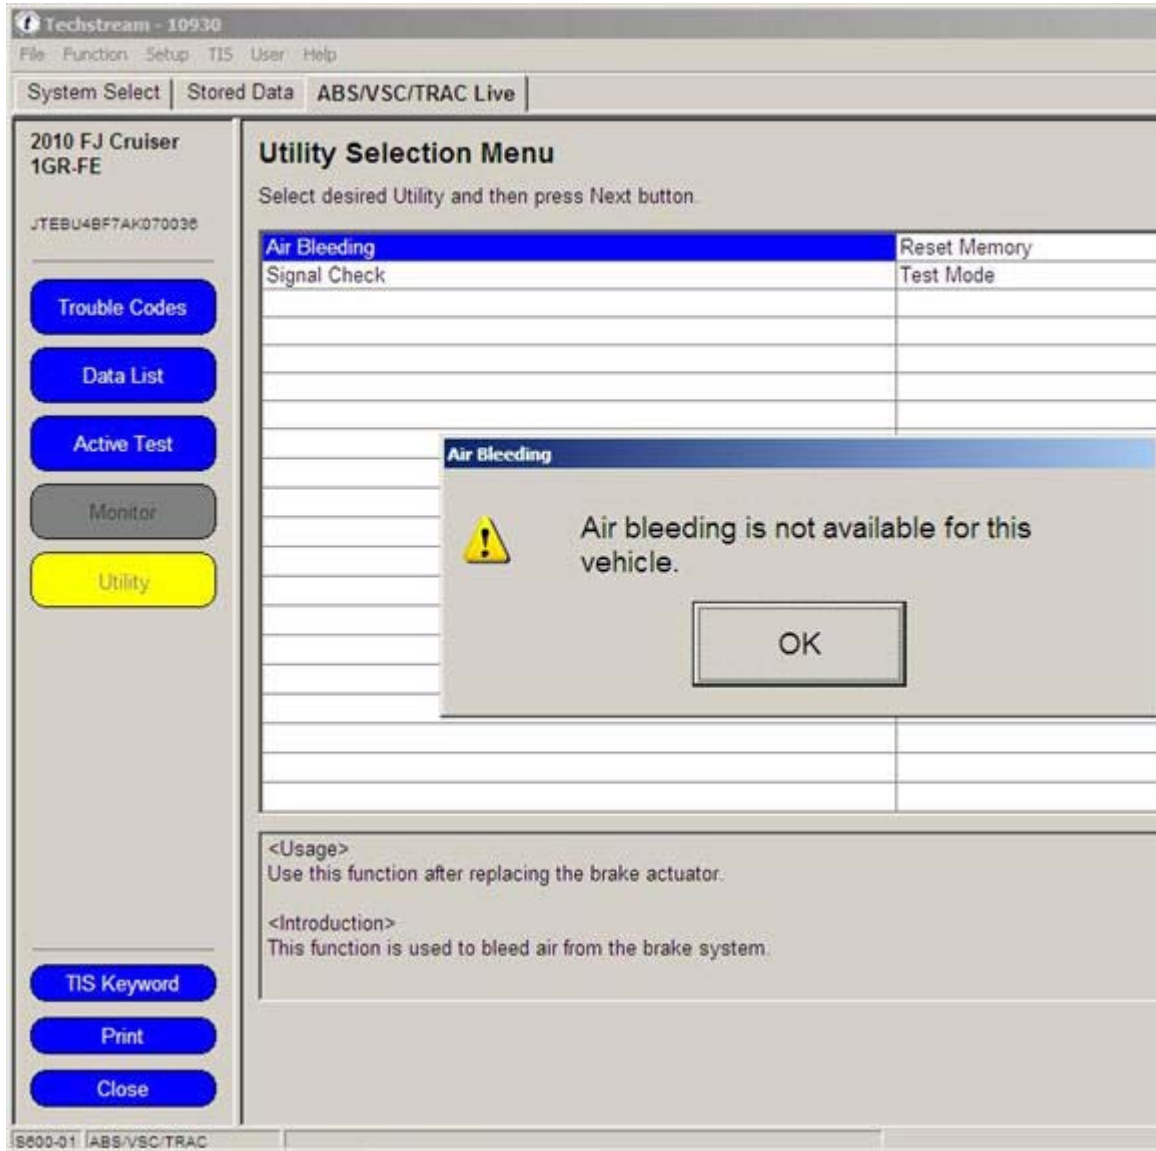
**Description:**When accessing the ABS Air Bleed Utility, an error window will display "Air bleeding is not available for this vehicle" and will not allow access to the utility.

**Status:**This issue is fixed in v.5.10 Techstream Software.

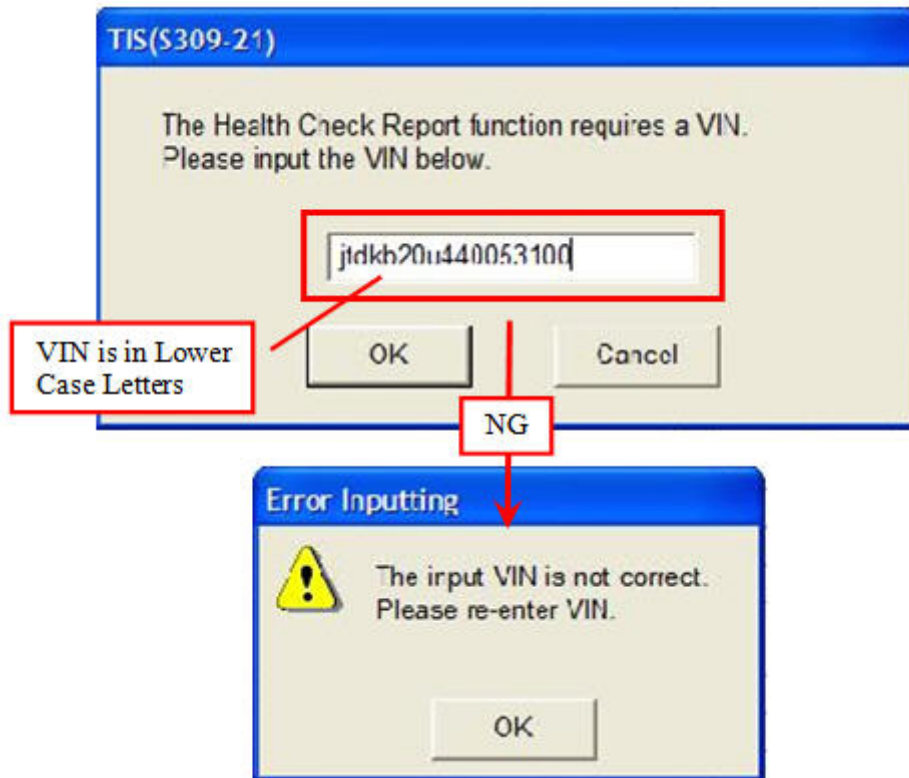
## 2. Unable to Generate Health Check Report when VIN Input is Required

will display saying the input VIN is not correct.

**Status:** This issue is fixed in v.5.10 Techstream Software.

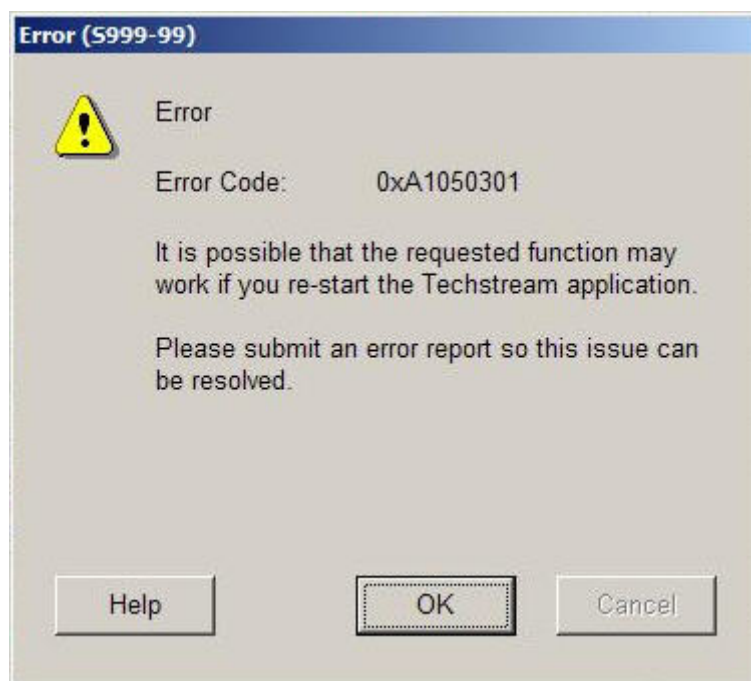
**Description:**When attempting to access the Engine ECU Data List, an error window may display. If the error displays, please try connecting to the same function again. The second attempt will most likely allow connecting to the data list, but the refresh rate may be slower than expected.

**Status:**This issue is fixed in v.5.10 Techstream Software.

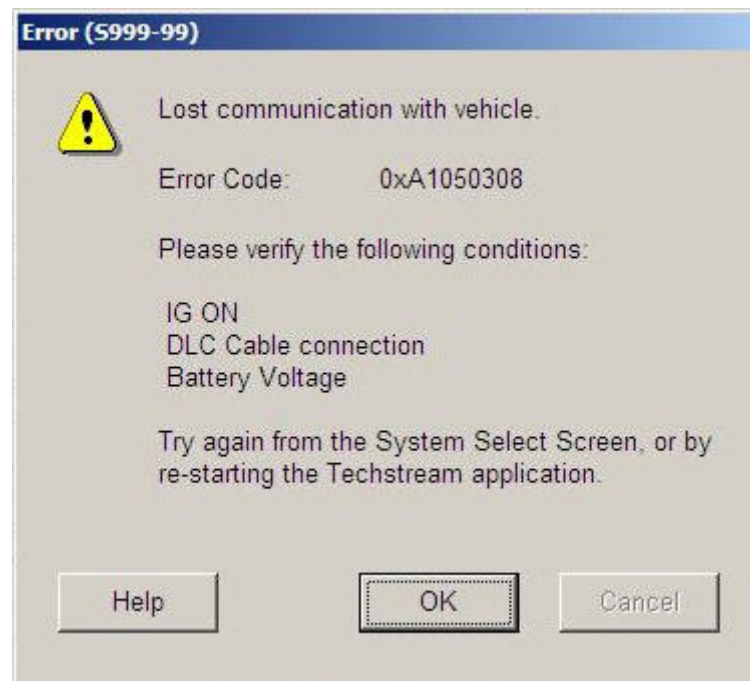
## 5. Transmission Control Data List Error

**Description:**An error window may randomly display after viewing the Transmission Control ECU Data List for an undetermined length of time. If an error occurs, please try connecting to the function again.

**Status:**This issue is fixed in v.5.10 Techstream Software.

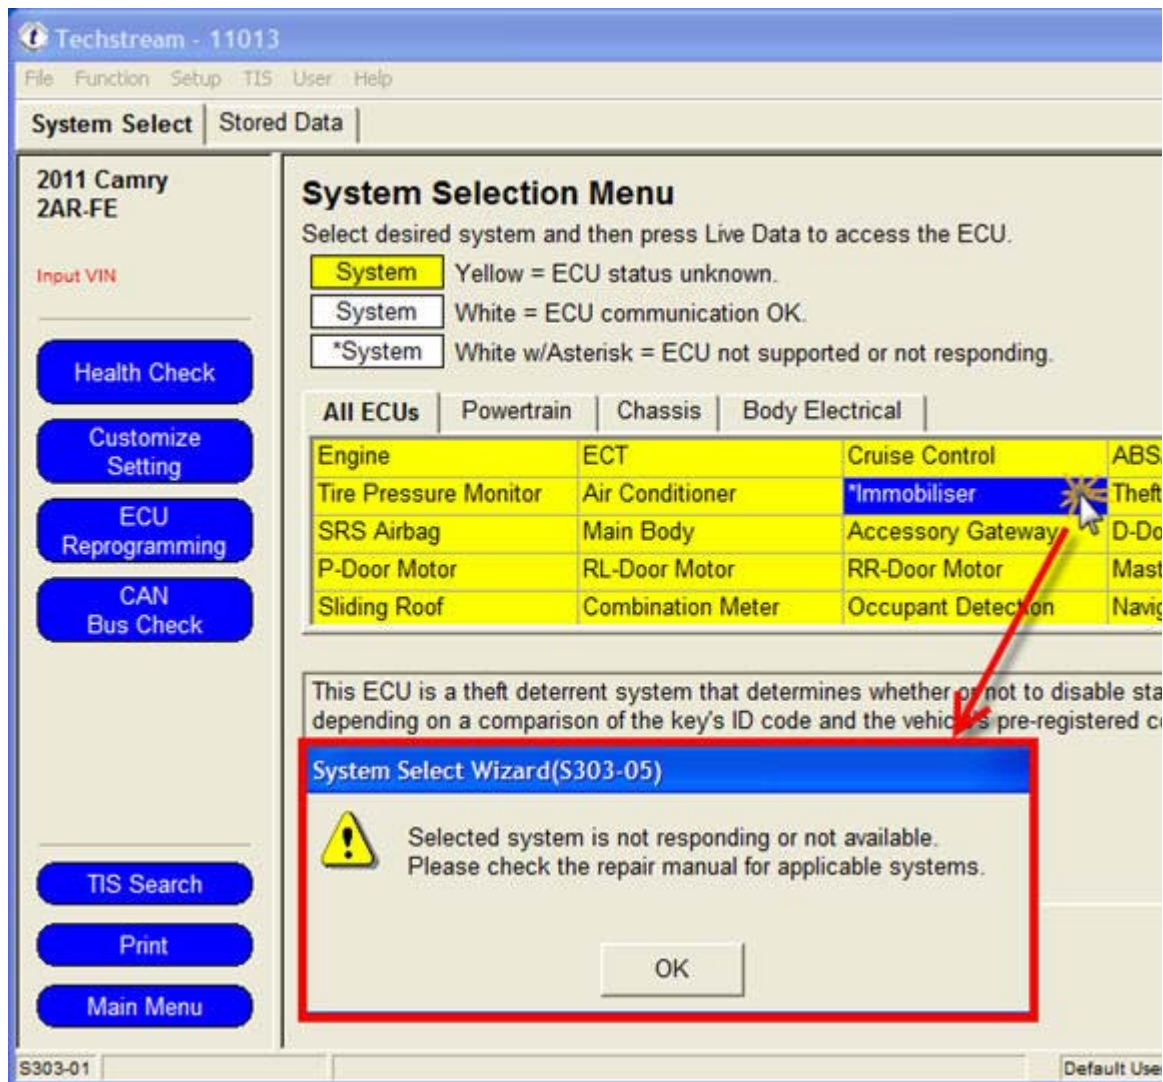
## 6. Unable to Access Immobilizer System

**Description:**When attempting to access the Immobilizer System, and error window will display indicating this system is not responding or not available.

**Status:**This issue is fixed in v.5.10 Techstream Software.

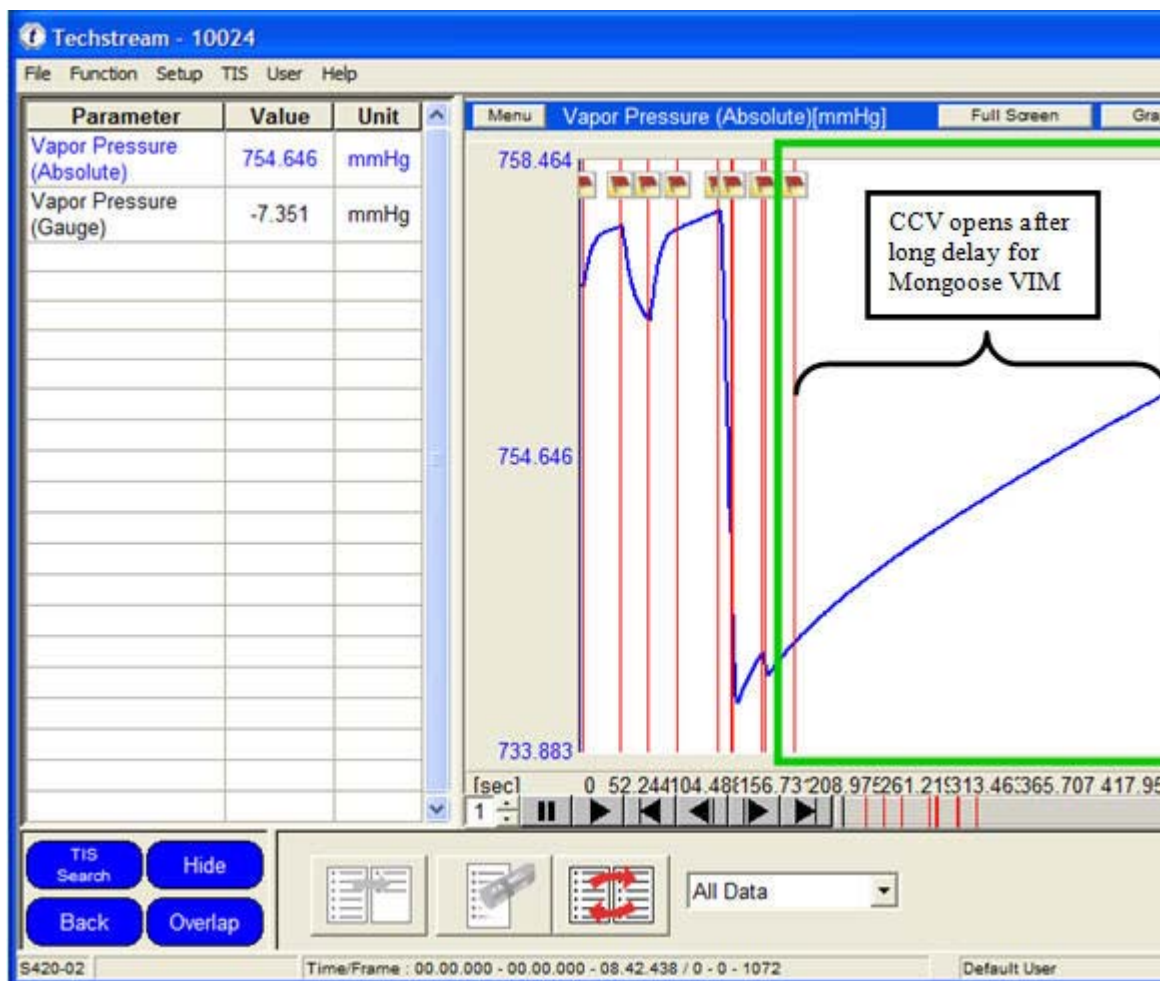
## 9. Evap System Check Error for Canister Control VSV

Late Type Evap Systems, a long delay occurs when the step involves changing the state of the Canister Control VSV (step 4 and 9). In some cases it may take a few minutes for the Canister Control VSV to physically open/close after clicking the "next" button in the Evap System Check Utility.

**Status:**This issue is fixed in v.5.10 Techstream Software.
