TOYOTA 官方 TIS3使用说明[图片]

## Known Bugs List

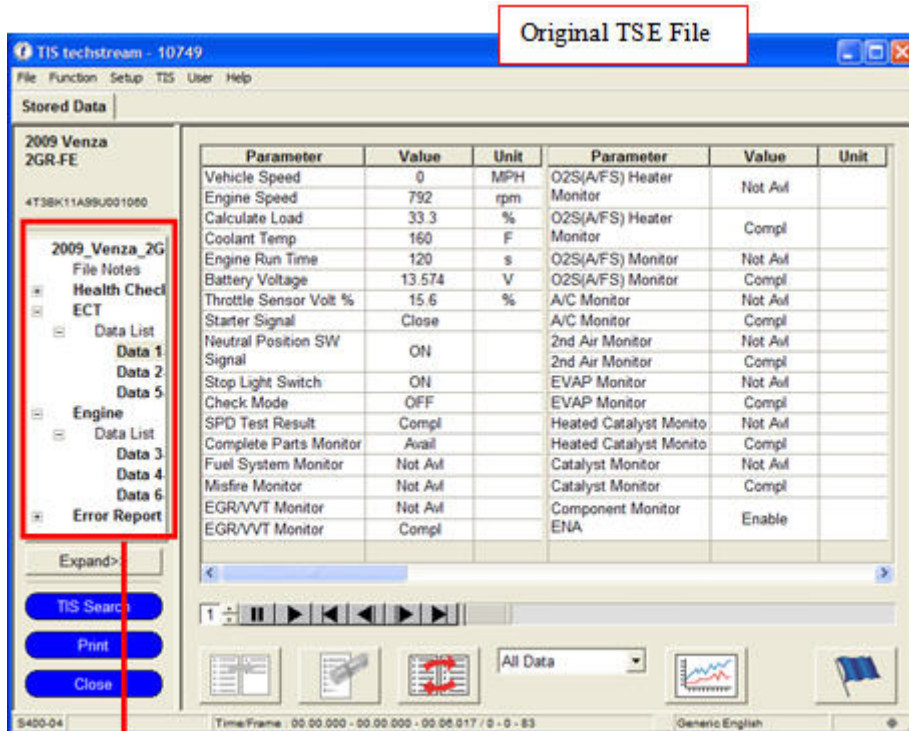
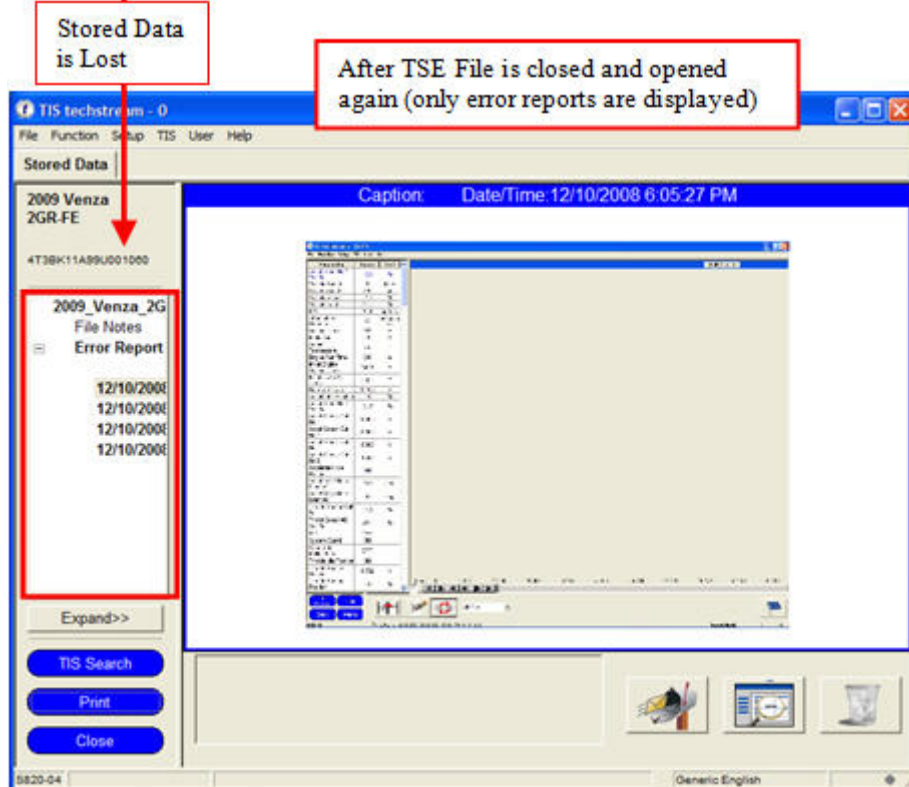
**Description:**When viewing and closing a saved TSE file, the file will lose all stored data intermittently and will only display Automated Error Reports the next time the file is opened.

**Status:**This issue is fixed in v.5.10 Techstream Software.
