TOYOTA 官方 TIS3使用说明[图片]

## Known Bugs List

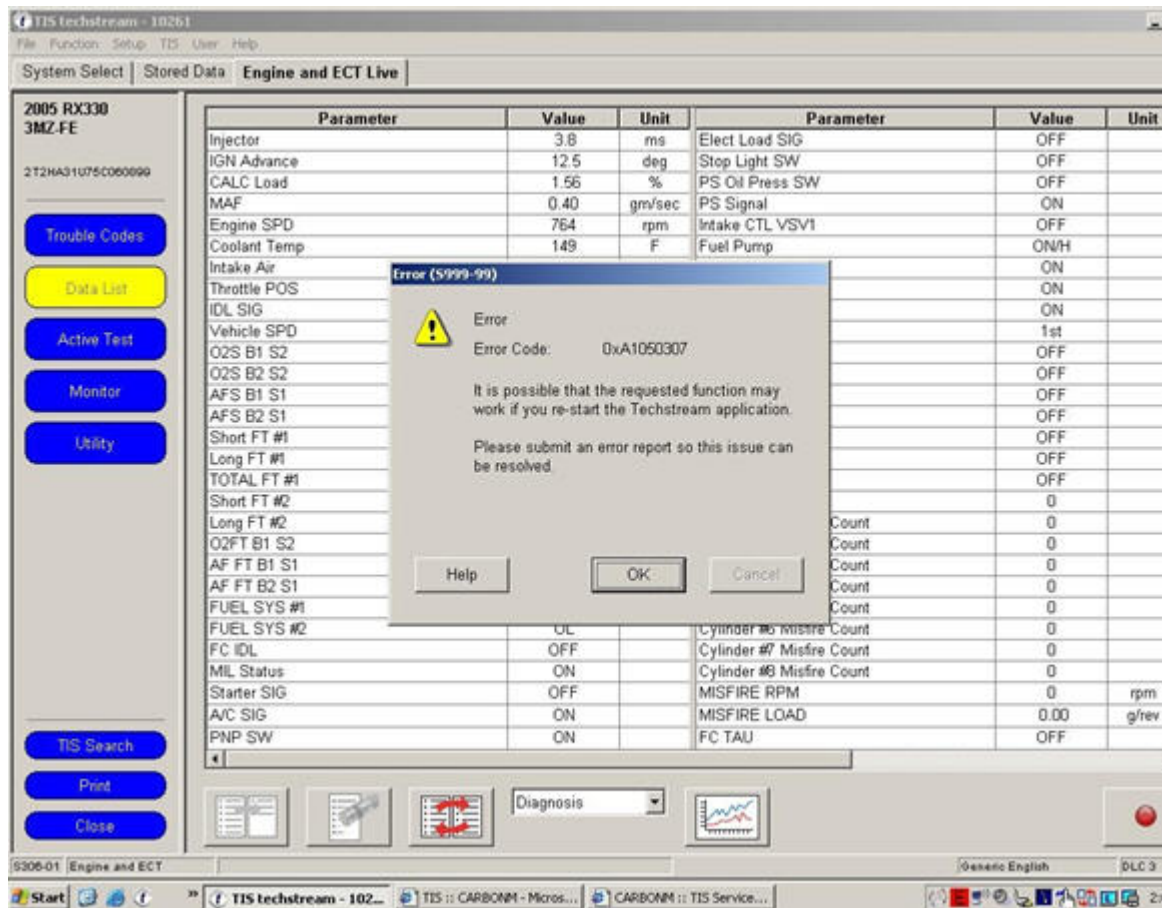
**Status:**This error is found to be isolated to a small number of units using the eTRUST brand Anti-Virus Software. Users have reported that the error symptoms disappeared after removing the eTRUST Anti-Virus Software.

**\*NOTES\*:**Users with McAfee and Norton Anti-Virus Software installed on Techstream have reported to not be experiencing this error screen.

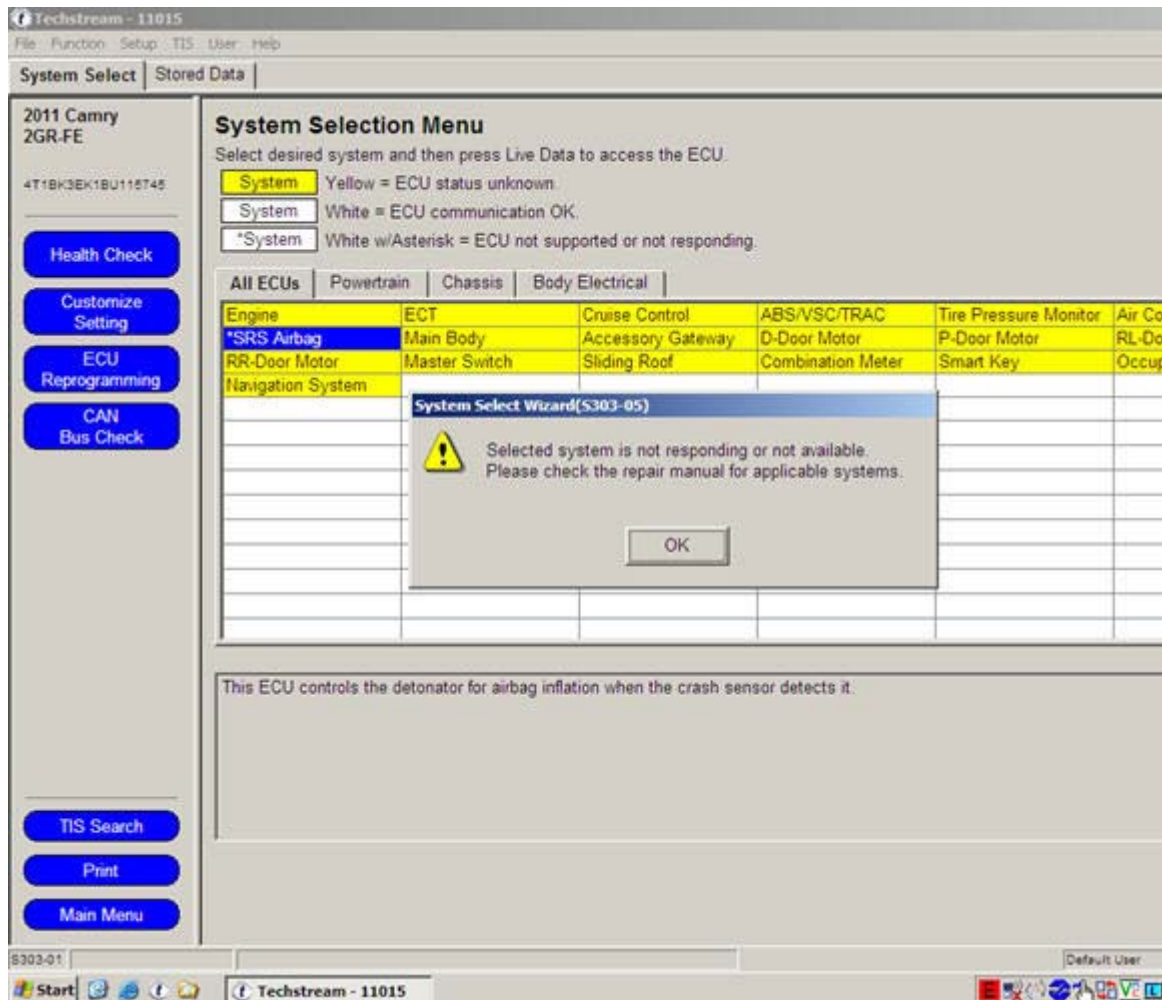
error screen results, indicating this system is not available on this vehicle.

**Status:**This issue is fixed in v.5.10 Techstream Software.
